Field-Experience Based Root-Cause Analysis of Power-Converter Failure in Wind Turbines

Katharina Fischer, Thomas Stalin, Hans Ramberg, Jan Wenske, Göran Wetter, Robert Karlsson, and Torbjörn Thiringer, *Senior Member, IEEE*

Index Terms—Converter, failure, power electronics, reliability, root-cause analysis, wind turbine.

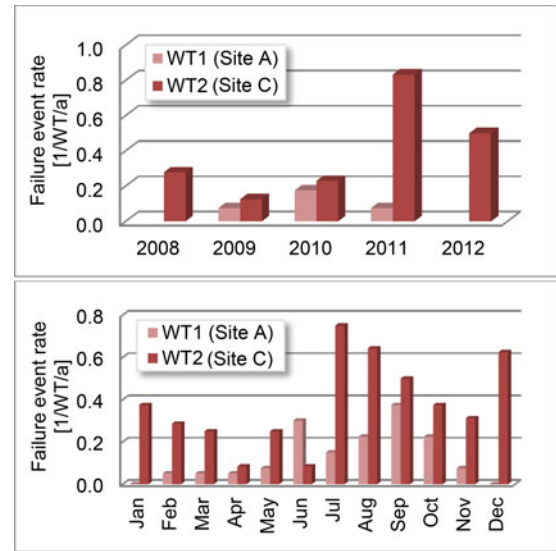
Fig. 3. Temporal distribution of converter failures in turbines of type WT1 (data from Site A, January 2009–April 2011) and WT2 (data from Site C, August 2008–February 2012).

The average annual converter failure rates are found to vary considerably over the years. While the period of observation is too short to identify possible age-related trends in the converter reliability, Fig. 3 reveals that the seasons summer and autumn are most critical with respect to converter failure at the sites considered.

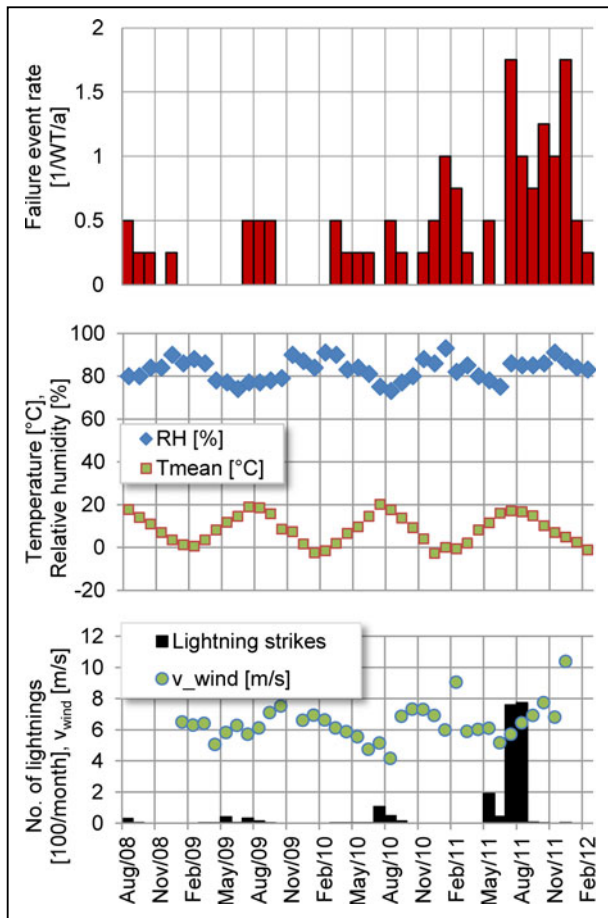
Fig. 4 shows the monthly number of converter failures together with the average values of the ambient temperature, the ambient relative humidity, and the wind speed in the respective month. Not surprisingly, the average temperature is highest during the summer months, while the relative humidity reaches its maxima in the winter and wind speed reaches the highest average values in autumn and winter.

Fig. 4. Converter failures and monthly average values of ambient temperature, relative humidity, wind speed and number of lightning strikes at Site C.

In case of WT1 at Site A, the only statistically significant correlation is found between converter failure and ambient temperature. Some negative correlation is observed with the relative humidity. However, as a failure rate decreasing with the relative humidity is physically not plausible, this should mainly be ascribed to the strong negative correlation ($r = -0.82$, $p < 0.001$) of temperature and relative humidity due to their aforementioned systematic relationship. No statistically significant correlation is found between converter failure and the average wind speed.

In contrast to the WT1-specific results based on data from Site A, no statistically significant correlation is found between converter failure and ambient temperature in the case of WT2 at Site C. While some correlation with the relative humidity is suggested by the monthly average data, the more reliable results obtained from the daily average data disprove this. A stronger, statistically significant correlation is found between the number of failures and the average wind speed. A more detailed analysis based on the daily average wind speed shows that this applies only for the nondestructive failures. In contrast, explosion failure is not correlated with the wind speed.

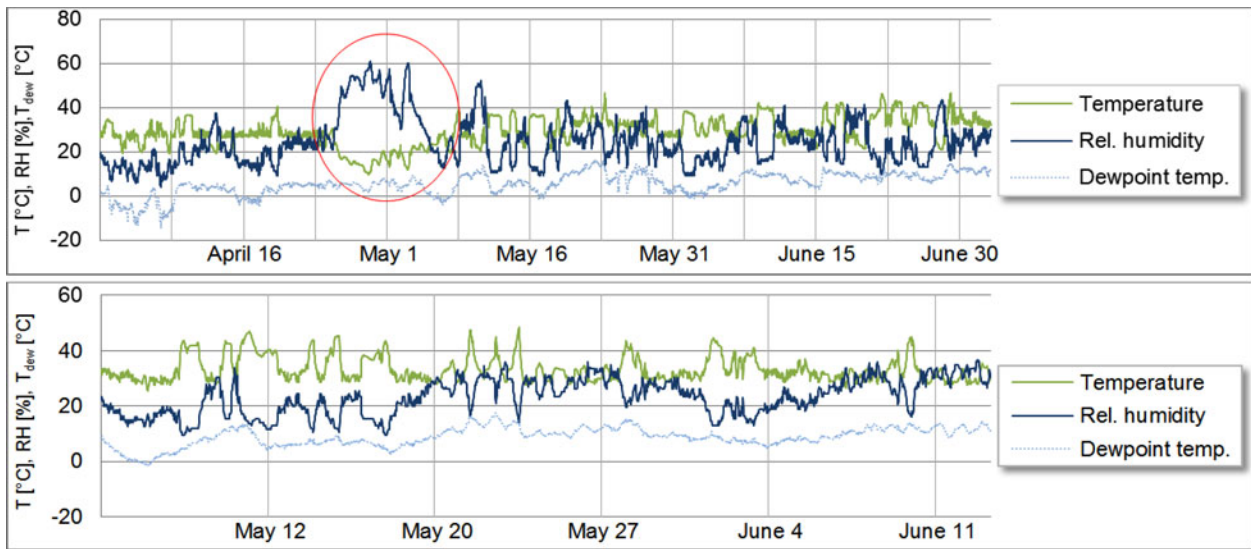
Fig. 5. Temperature, relative humidity, and corresponding dew-point temperature inside the converter cabinet of a turbine of type WT1 (top, data from offshore Site A) and WT2 (bottom, data from offshore Site C).

An interesting case could be logged on a WT1 turbine at the offshore Site A; see Fig. 5 during end of April and early May: after a standstill period of 9 days and 2 days of major repair work with an opened nacelle, a converter failure occurred during start-up of the turbine on 4 May. Similar cases were reported to have occurred before in the same offshore wind park. The logged temperature and relative-humidity data confirm that this most likely is related to condensation: due to the standstill period, the nacelle cools down and the relative humidity increases to values of approximately 60%. This results in a low difference between

the temperature logged at the top inside of the converter cabinet and the corresponding dew-point temperature, which is likely to have caused condensation on the converter modules as these have a high thermal inertia.

In summary, it can be stated that the converter operating conditions are uncritical with respect to temperature and humidity during normal turbine operation but appear to be problematic with respect to condensation after long periods of standstill.

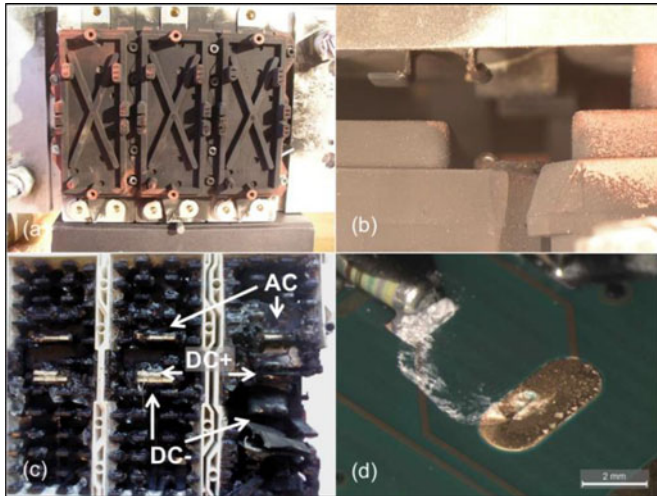
In the first investigated power module, denoted M1, evidence was found of high-voltage flashover between a cooling fin soldered to the gate-driver board and a screw fixing one of the half-bridges to the heat sink; see Fig. 6(a) and (b). The dielectric strength of air is approximately 3 kV/mm. Thus, to initiate a flashover over a gap of 7 mm between the cooling fin and the screw, a voltage of approximately 20 kV and therefore a multiple of the normal operating voltage of <1 kV is required. The material transferred from the cooling fin to the screw indicates that the cooling fin must have been on a high negative potential with respect to the screw. Four possible scenarios that might have caused the observed damage were discussed.

Fig. 6. (a) and (b) Signs of high-voltage flashover between a screw and a PCB cooling fin, (c) melting pattern in module-internal busbars, (d) contamination and corrosion products on a gate-driver board.

Not surprisingly, also the analysis of the second destructed module, M2, has revealed signs of very high currents through the module. As Fig. 6(c) shows, all three paralleled half-bridges have the same damage pattern: The connections to the DC+ and the ac side show melting in the same contact points. The considerable displacement of the DC- connection from the DC+ connection observed in Fig. 6 (c) gives evidence of a very strong energy release. Regarding the origin of this energy release, no clear evidence could be found. Among the potential mechanisms resulting in destruction is a resonance of the signal contact

An irregularity discovered in module M2 was corroded spots at the bottom side of the DCB as well as on the upper side of the nonanodized aluminum heat sink. In the area of these spots, no thermal grease was found left between the two surfaces and the inert gold-layer covering the bottom side of the DCB was damaged. SEM/EDS analysis of one of the spots showed that it predominantly consists of aluminum and copper, i.e., of material from the heat sink and the DCB. No traces of chlorine were found, which could have pointed to the ingress of salt. The positions of the spots coincide with the points in which the DCB is pressed to the heat sink by means of the plastic pins visible in Fig. 6(c). In combination with the chemical composition of the spot, this observation strongly suggests the presence of fretting: Under the impact of mechanical pressure, thermal cycling and possibly also promoted by vibration, abrasive wear of the two surfaces takes place. The craters caused by this effect were found to reach no further than approximately 75 μm over and into the DCB surface, which is not considered critical for the integrity of the DCB. An interesting question requiring further investigation is if the fretting spots are afflicted with an increased thermal resistance, as only in that case, it would be considered a reliability-critical phenomenon. Possible countermeasure concerning the formation of the observed spots could be the anodizing or the creation of a finer structure of the heat-sink surface. An additional observation made in module M2,

The key finding in module M3, which also constitutes a possible failure cause, was the observation of contamination spots and likely corrosion products at several positions on the PCB; see Fig. 6(d). A SEM/EDS analysis of the contamination revealed the presence of sodium and chloride, indicating impact from the sea based environment, i.e., moisture and salt.

In the context of the described flashover damage, the air gap between the cooling fin and the screw is regarded relatively small. Besides using a design with a larger air gap, a measure to prevent flashover in this part of the module could be the introduction of a thin insulating sheet of, e.g., Kapton or Mica in the gap.

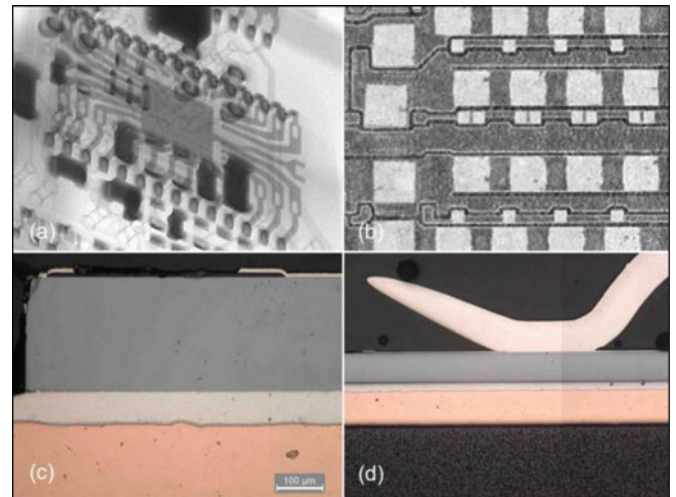
Fig. 7(b) shows an image from SAM analysis of the die-attach solder of the IGBT and diode chips of a half-bridge in converter module M3. The SAM analysis showed similar acoustic signal response from all chips in the half-bridges of both M3 and M4, indicating intact die attach solder in all chips.

Finally, the results of the SAM analysis and the bond-wire pull test have been verified by means of microsectioning and cross-sectional inspection of two IGBT chips. Fig. 7(c) and (d) shows optical microscopy cross-sectional images of an IGBT chip from a half-bridge in converter module M4. The cross-sectional inspections revealed intact die-attach solder without any signs of crack initiation. The bond-wire connections showed

Fig. 7. (a) X-ray inspection of driver-board solder-joints, (b) graphical representation (excerpt) of scanning-acoustic-microscopy signal from die-attach solder of IGBT and diode chips, (c) cross-sectional inspection of die-attach solder, and (d) bond-wire attachment to chip.

largely satisfactory attachment, apart from small crevices at the bond-wire heel. This could be the initial stage of a fatigue crack, but could also have been caused by a not fully melted bond zone during the wire-bonding operation.
