## Case Study of an Electric Vehicle Battery Thermal Runaway and Online Internal Short-Circuit Detection

**Abstract**—A thermal runaway happened in a battery cell of an electric vehicle during driving, and the fire spreads to other batteries in a few minutes. Based on the recorded battery operation data, this letter analyzes the battery thermal runaway process, and identifies the critical time points of fault signals like cell voltages and temperatures, etc., which depict the start and spread of thermal runaway in the battery pack. By tracing back the clues, it is concluded that the cause of the fire is battery internal short circuit (ISC), and battery overcharge is a potential cause of ISC. Then, three different patterns of battery cell voltage abnormalities are compared, including battery external short circuit, ISC, and poor-signal wire connection. A cell voltage difference-based method is proposed to diagnose ISC online, which is simple and reliable to implement in engineering.

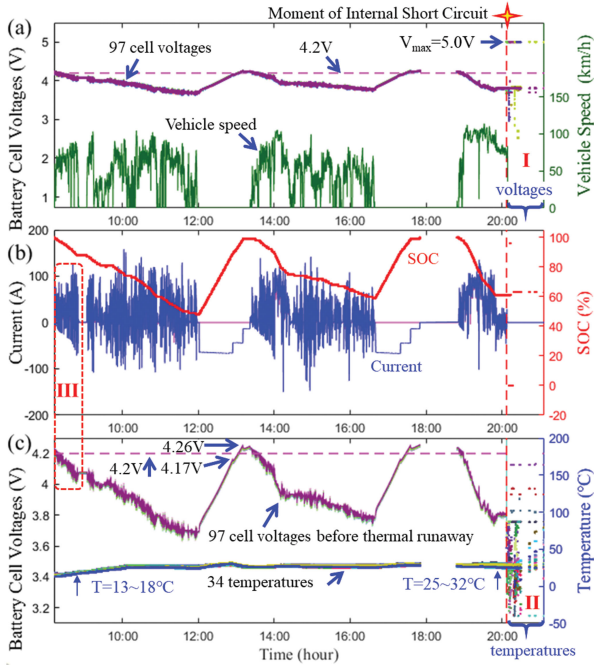
Fig. 1 shows the vehicle operation data of the day when TR happened. The vehicle started to operate from about 8:00 A.M. and operated normally during the day until TR occurred at 20:07:13 P.M. The battery temperatures were

Fig. 1. EV operation data of the day. (a) Cell voltages and vehicle speed. (b) Current and state-of-charge (SOC). (c) Cell voltages and temperatures.

between  $13^{\circ}C$  and  $32^{\circ}C$ , and the maximum charging/discharging currents were below 1 C-rate. The vehicle was driven more than 400 km during the day. The odometer reading was about 10 000 km, which suggests the vehicle was fairly new.

Fig. 1(c) shows that each charging process consists of three stages: 65 A charging to 4.17 V, then 44.7 A, and 13.5 A charging to 4.26 V, respectively. For most LiNMC traction batteries, the charging cutoff voltage is set to 4.2 V, and many OEMs are trying to avoid fully charging the batteries to ensure safety and prolong battery cycle life. However, the OEM of this EV is trying to overcharge the batteries to achieve a longer driving range. According to Table I, approximately 10% more energy (6 kWh) was charged to the batteries in stages 2 and 3, which could extend the EV driving range by 44 km (13.5 kWh/100 km). Area III in Fig. 1(b) also shows that this EV allows braking energy recovery

from 100% state-of-charge (SOC), which should be prohibited above 95% SOC.

Although we cannot draw a concrete conclusion that overcharge is the cause of this TR accident, it is still highly recommended not to overcharge the batteries.

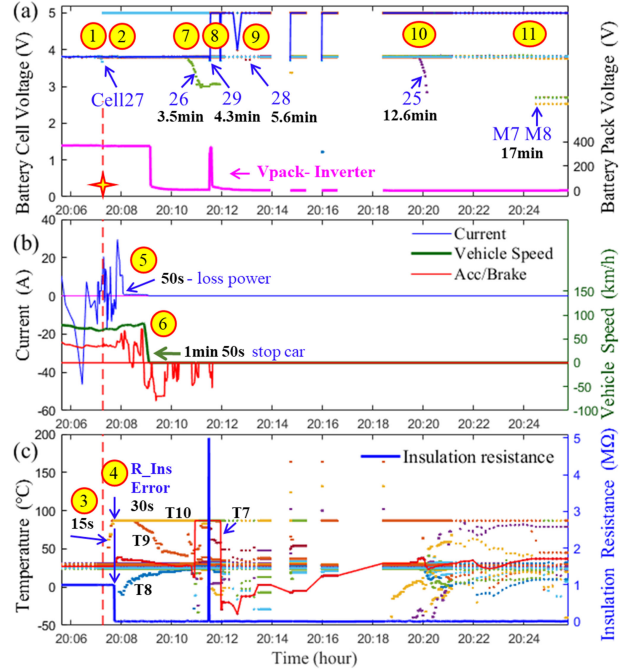
After TR started at 20:07:13 P.M., many signals began to show fault readings, as depicted in regions I and II of Fig. 1. A zoomed-in figure after TR is shown in Fig. 2. The battery cell voltages scattered between 2 and 5 V. Some batteries experienced continuous voltage drop, including cell 27, 26, and 25, as illustrated in Fig. 3(a)–(c).

Temperatures in Fig. 2(c) scattered between  $-40$  and  $85^{\circ}C$ , which is the limit of temperature readings in the BMS. Negative temperature coefficient (NTC) sensors are usually used to measure temperatures. High sensor resistance indicates low temperature. When the NTC signal wires got burned in the fire during the accident, the resistance of the signal wires would increase dramatically, thus inducing low-temperature readings in the BMS. After the fire went out, temperature readings would recover gradually. Therefore, subzero temperature readings can be used as evidences of fire in the battery pack.

Fig. 2. Battery TR and its propagation. (a) Battery cell voltages and battery pack voltage. (b) Current and vehicle speed. (c) Temperatures and insulation resistance.

*Step 3:* 20:07:28 (15 s): Temperatures 9 (T9) and 10 (T10) of submodule 05 (M05) rose to above 60 °C. Both the high temperatures and their rising rate should have triggered the warning in the BMS.

*Step 4:* 20:07:43 (30 s): T9 and T10 rose to above 85 °C, whereas T8 dropped to subzero. The insulation resistance ( $R_{Ins}$ ) dropped from 1 M $\Omega$  to zero, which means there was a high-voltage leakage to the vehicle chassis. The clues indicate that the flame had burst out of submodule 5. Then, in the next 3 min, T8 and T9 recovered toward normal temperature gradually, indicating the flame of battery cell 27 went out gradually.

With the voltage error, temperature errors and  $R_{Ins}$  error, the BMS should have already detected TR at this moment and given the driver the highest level warning to escape.

*Step 6:* 20:09:03 (1 min 50 s): The vehicle speed was about 61 km/h, then the driver stopped the car, and the dc bus voltage of the inverter was disconnected. However, the Acc/Brake pedal signal in Fig. 2(b) shows that the driver did not evacuate immediately but tried to restart the vehicle 2 min later on Step 8.

In this approach, ISC could be identified even before a high temperature is detected. Thus, the warning could be advanced by at least 15 s, i.e., from Step 3 to Step 2 in Fig. 2. False alarms could also be avoided by considering different voltage failure modes. The simplicity and reliability of the method make it promising for engineering applications.

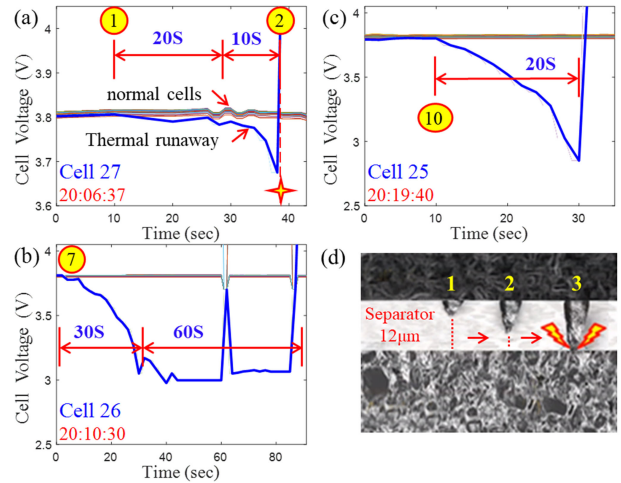
Due to the BMS setting, the measured battery voltages out of normal range (i.e., 2.8–4.3 V) were recorded as 5 V to indicate error state. Therefore, in Fig. 3, the voltage readings jumped to 5 V during the voltage drop process, although in fact the voltages were still dropping.

Fig. 3. Voltage drop of battery TR. (a) TR of battery cell 27. (b) TR of battery cell 26. (c) TR of battery cell 25. (d) Separator pierce process of cell 27.

*Step 1:* 20:06:47 (–26 s before TR): Fig. 3(a) shows that the voltage of battery cell 27 ( $V_{27}$ ) started to diverge from other batteries gradually, which indicates ISC began to develop inside battery cell 27.

*Step 2:* 20:07:13 (0 s—the moment of TR):  $V_{27}$  started to plunge quickly, suggesting a violent TR happened. The BMS should have already detected the cell voltage abnormality.

A possible theory of the TR is that a lithium dendrite or burr was growing on the surface of anode or cathode, and finally it pierced through the separator after hundreds of charging cycles and caused micro short circuit, as illustrated in Fig. 3(d). Heat

and gas generated in the process aggravated the short circuit, and 26 s later, a violent TR occurred.

*Step 7:* 20:10:52 (3.5 min): TR started in battery cell 26 due to overheat, as depicted in Fig. 3(b). V26 dropped from 3.8 to

3.0 V in 30 s, then sustained for 60 s before it dropped out of the normal range. This is because the separator holes were closed under 140–170 °C [1]; thus, the TR was stopped temporarily, then with a totally melt down of the separator, a violent TR happened again [7].

*Step 10:* 20:19:53 (12.6 min): TR occurred in battery cell 25, as depicted in Fig. 3(c). Then, the explosion caused the battery measurement unit (BMU) to restart, thus V1–V47 signals were offline for a few seconds, as shown in Fig. 4(a).

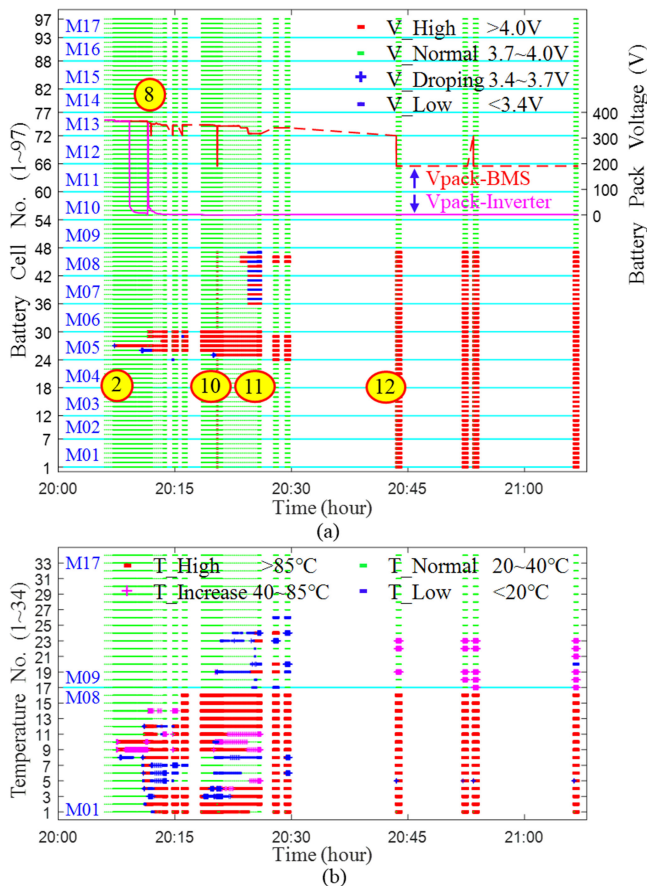
Fig. 4 shows the battery cell voltage and temperature fault signals propagation in the battery pack. The gaps in the signals suggest that the BMS was waken up nine times after TR.

Fig. 4. Battery cell voltage and temperature fault signals propagation map. (a) Battery cell voltage error propagation (b) Temperature error Propagation.

*Step 11:* 20:23:09 (17 min): Battery voltage signal errors of V36–V47 (M07 and M08) were detected. But the pattern seems like signal wire or BMS failure but not a TR.

*Step 12:* 20:43:29 (37 min) to 21:06:00 (1 h): In M01–M08, all signals (V1–V47 and T1–T14) were offline. This suggests the BMU was damaged in the fire. It is not clear whether TR spread to other submodules besides M05. In M09–M17, all battery cell voltages were normal, suggesting TR was not spread to these submodules. However, there were still high temperatures detected in M09–M11.

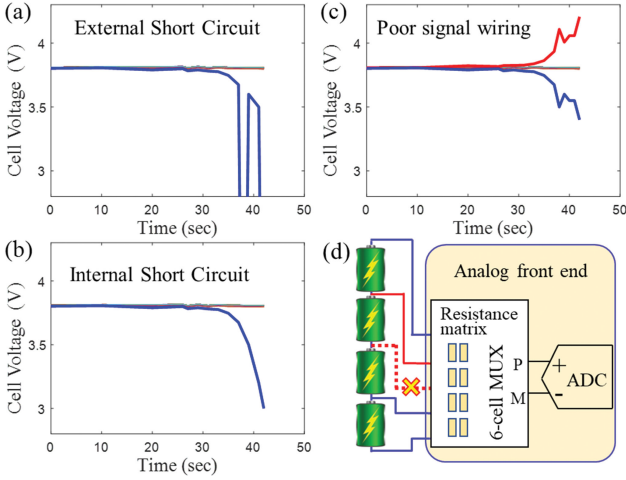
Fig. 5. Different patterns of battery cell voltage fault signals. (a) Battery external short circuit. (b) Battery ISC. (c) Poor voltage signal wire connection. (d) Voltage measurement and poor signal wiring.

Fig. 5 compares three different battery voltage fault signal patterns. When an external short circuit occurs, the battery voltage would drop dramatically to nearly zero, and may jump back and forth. In the case of ISC, there would be a continuous voltage drop process. Poor voltage signal wiring is usually caused by a loose connector. In this case, usually the two adjacent voltage readings would diverge to opposite directions, because the poor contacted voltage signal is floating while the upper voltage channel loses ground reference, as depicted in Fig. 5(c) and (d). Therefore, the continuous voltage drop is a unique feature of battery ISC, and this feature can be used to detect ISC online.

Based on the analysis, in the BMS software, a 10-s time window could be established to monitor the latest  $\Delta V'_{\max}$  value. If the signal is detected to be continuously in the range of

5–150 mV/s for more than 8 s, and if the possibility of signal wiring failure could be ruled out, then the BMS could confirm that a battery ISC occurred.
