Degradation Assessment in IGBT Modules Using Four-Point Probing Approach

Abstract—Four-point probing of electrical parameters on various components of IGBT modules is suggested as an approach for the estimation of degradation in stressed devices. By comparison of these parameters for stressed and new components one can evaluate an overall degradation of the module and find out the wear state of individual components. This knowledge can be applied for preventing early failures and for optimization of the device design. The method is presented by regarding a standard type power module subjected to power cycling.

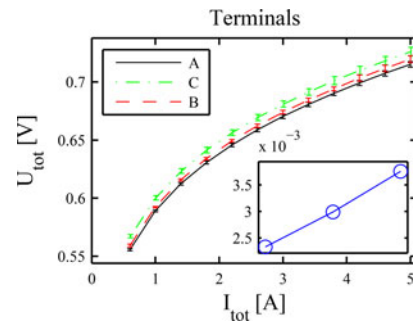
Fig. 4. Mean value of the potential difference between terminals plotted against the applied current with errorbars indicating the spread between the sections. The inset illustrates the voltage spread for three modules at 5 A.

1) *Sections*: In Fig. 4, the electrical potential difference between terminals T_I and T_{out} (across IGBTs) as a function of the applied current is presented. The data are averaged on five sections for every module. In all three curves, deviations obtained on different sections are included as errorbars.

From Fig. 4, the voltage drop is clearly seen to increase with the number of cycles, indicating that the effective resistances of the sections are increased. This shows that the sections degrade over time when power cycled, as would be expected. One can also see that standard deviations are larger for C compared to A and B indicating that degradation is not evenly distributed among the sections. This is illustrated in the inset of Fig. 4, where the voltage spread is plotted for the three modules. The potential differences from T_{out} to T_D (across diodes) were all found to be within the errors measured for module A.

typical for module A. Therefore, it becomes obvious that the voltage change presented in Fig. 4 is related to the degradation of the bond wire interfaces.

By measuring the electrical potential difference across individual sections of stressed modules, it was possible to establish the type of failure present. As seen in Fig. 4, the I - V dependences for IGBTs are nonlinear. However, the increase of voltage from module A to B and further to C has linear dependence, i.e., corresponds to ohmic behavior. The observed ohmic change indicates material fatigue, like mechanical creep of the solder or fracturing of the wire interface. Furthermore, by comparing the change in forward voltage for different sections of the same module, i.e., the spread presented in the inset, one can conclude that the power load is distributed unevenly through the sections because the spread increases. Fatigue is a fundamental occurrence in power cycled modules, however, unevenly distributed fatigue is undesired as the regions stressed additionally can cause early failures. For the diode chips, the change of voltage for B and C modules was found to be within the standard deviations characteristic for the new module. Thus, one can conclude that there is no considerable degradation of diodes and related interfaces that is also confirmed by the microscopy investigations.

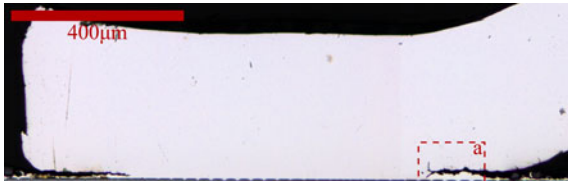
2) *Microsectioning*: In Figs. 13 and 14, cross-sectional views of a bond wire interface are presented. They are obtained using microsectioning combined with optical microscopy. The interface corresponds to the end bond of $C-S_1-w_3$.

In Figs. 13 and 14, fractures propagating from both edges of the bond more than 150 μm inwards can be observed. At the heel of the end bond, the fracture reaches ca. 50 μm above the chip/metallization interface. From earlier studies, it is know

Fig. 13. Optical microscopy image of a wire/IGBT interface on section 3 of module C.

that this fracture development goes through the area in the wire, which correspond to gradual interface between the refinement and deformation regions, see [4] and [14].
